11. TITLE (Include Security Classification) Rehabilitation of Navigation Lock Walls: Case Histories					
12. PERSONAL AUTHOR(S) McDonald, James E.					
13a. TYPE OF REPORT Final Report	13b. TIME COVERED FROM TO	14. DATE OF REPORT (Year, Month, Day) December 1987		15. PAGE COUNT 316

means for removing large quantities of concrete. Once the deteriorated concrete has been removed, conventional cast-in-place concrete has been used as the replacement material in most lock wall rehabilitation projects. Other replacement systems that have been used or proposed include shotcrete, preplaced-aggregate concrete, and precast concrete stay-in-place forms. In addition, several materials including latex-modified concrete, polymer mortars and grouts, conventional shotcrete, and latex-modified, fiber-reinforced shotcrete have been used as thin overlays on existing lock walls. Applications of the various rehabilitation systems and their performance to date are described in selected case histories.

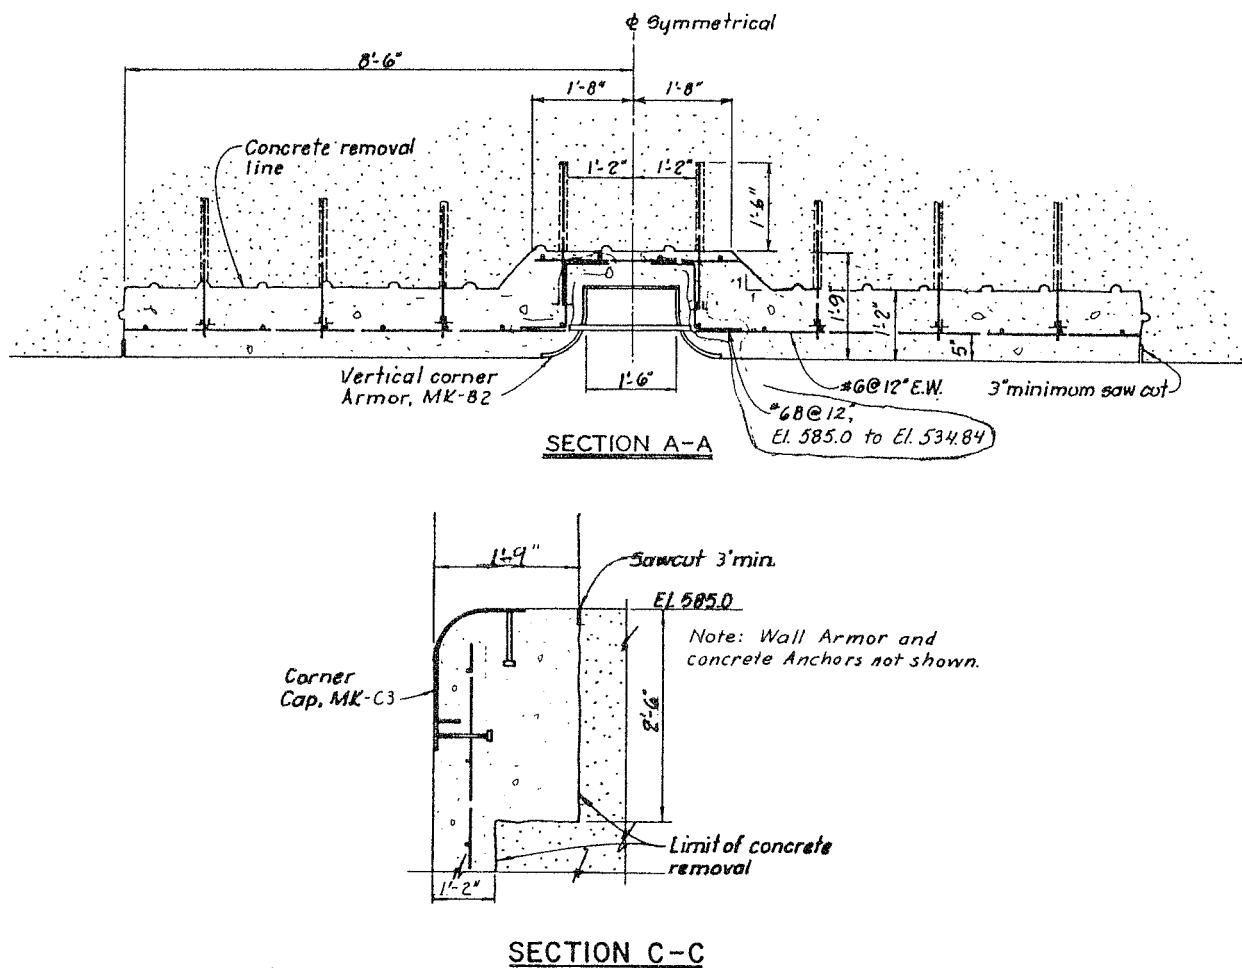
Figure 149. Ladder details of Sections A-A and C-C, Lockport Lock

each way, to anchor the replacement concrete instead of the Richmond anchors shown in the plans (Figure 149). These bars were grouted into 1-in.-diam holes drilled 18 in. into the existing concrete using polyester resin grout. Following installation of the ladders, conventional reinforcing, and armor, the ladder areas were formed in 5-ft lifts (Figure 152). Concrete placement on the landside wall was accomplished by discharging the concrete directly from transit mixers into hoppers filled with flexible hose commonly known as elephant trunks (Figure 153). Concrete on the riverside wall was placed in similar manner except the concrete was transported from the landside wall by concrete bucket and crane. Internal vibrators were used to consolidate the fresh concrete. Forms were usually stripped one day after concrete placement, and a membrane curing compound was applied to formed surfaces. A partially completed ladder section is shown in Figure 154. Some cracking was observed

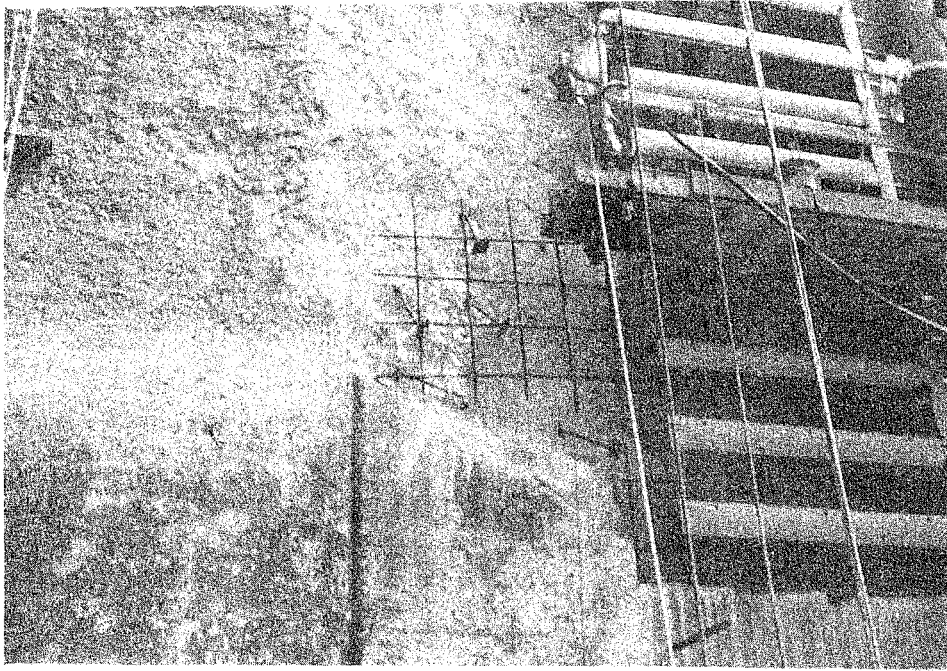
Figure 151. Concrete overbreak during removal,  
Lockport Lock

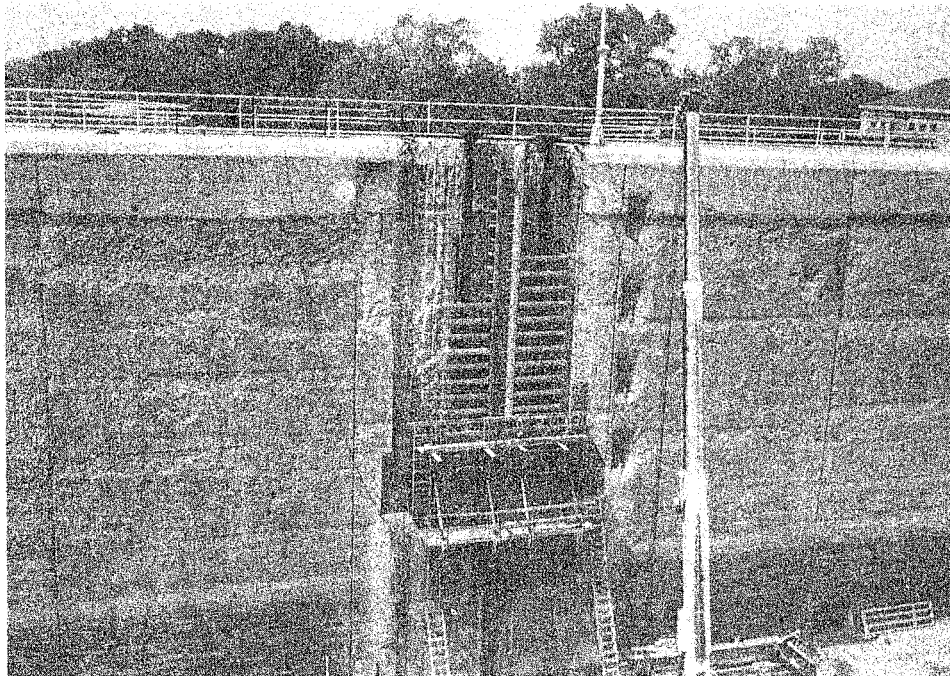
Figure 152. Overbreak area prepared for repair,  
Lockport Lock

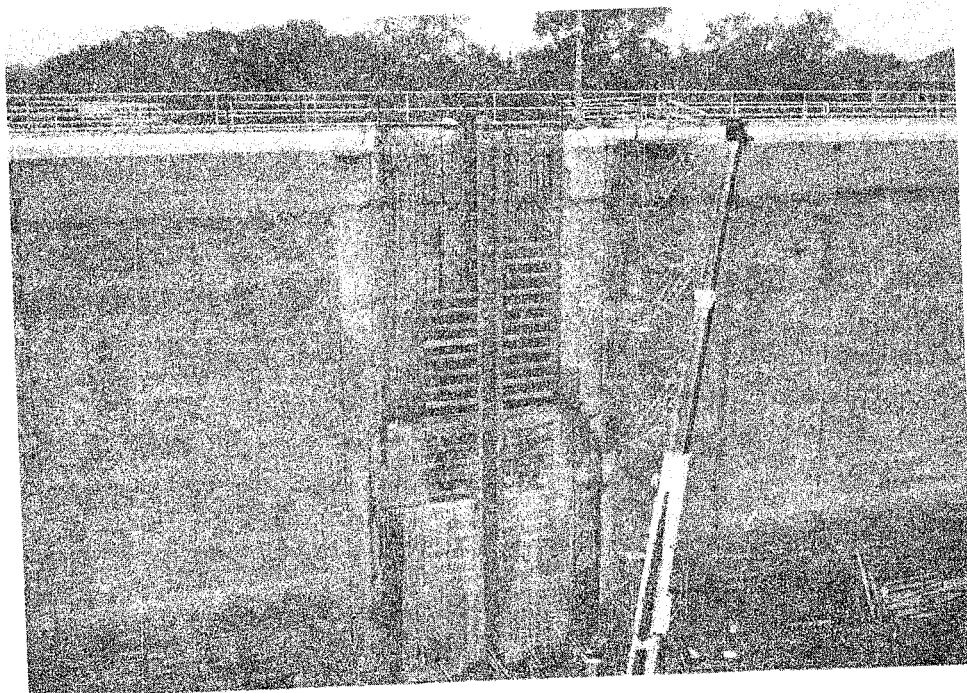
Figure 154. Partially completed ladder section,  
Lockport Lock

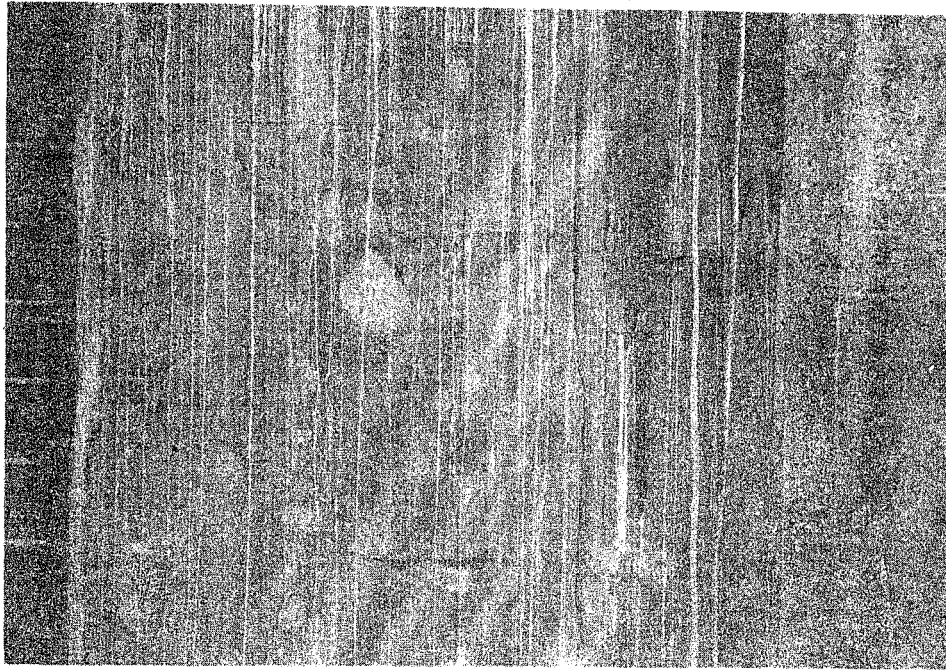
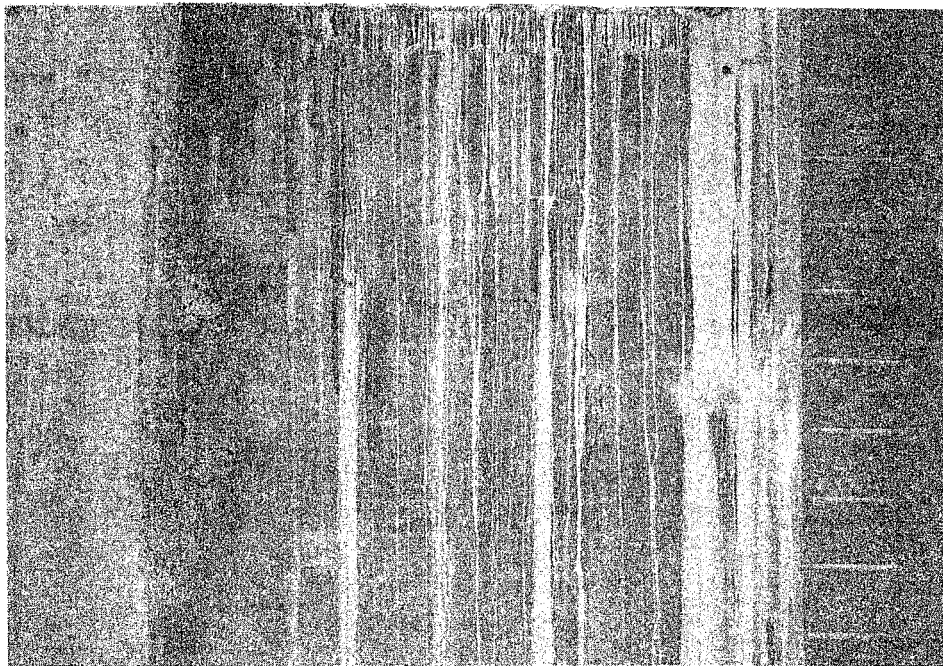
in the replacement concrete, particularly in the lower lifts where armor was not present (Figure 155). The contractor's bid price for ladder installation was approximately \$350,000.

Figure 155. Cracking in the replacement concrete,  
Lockport Lock

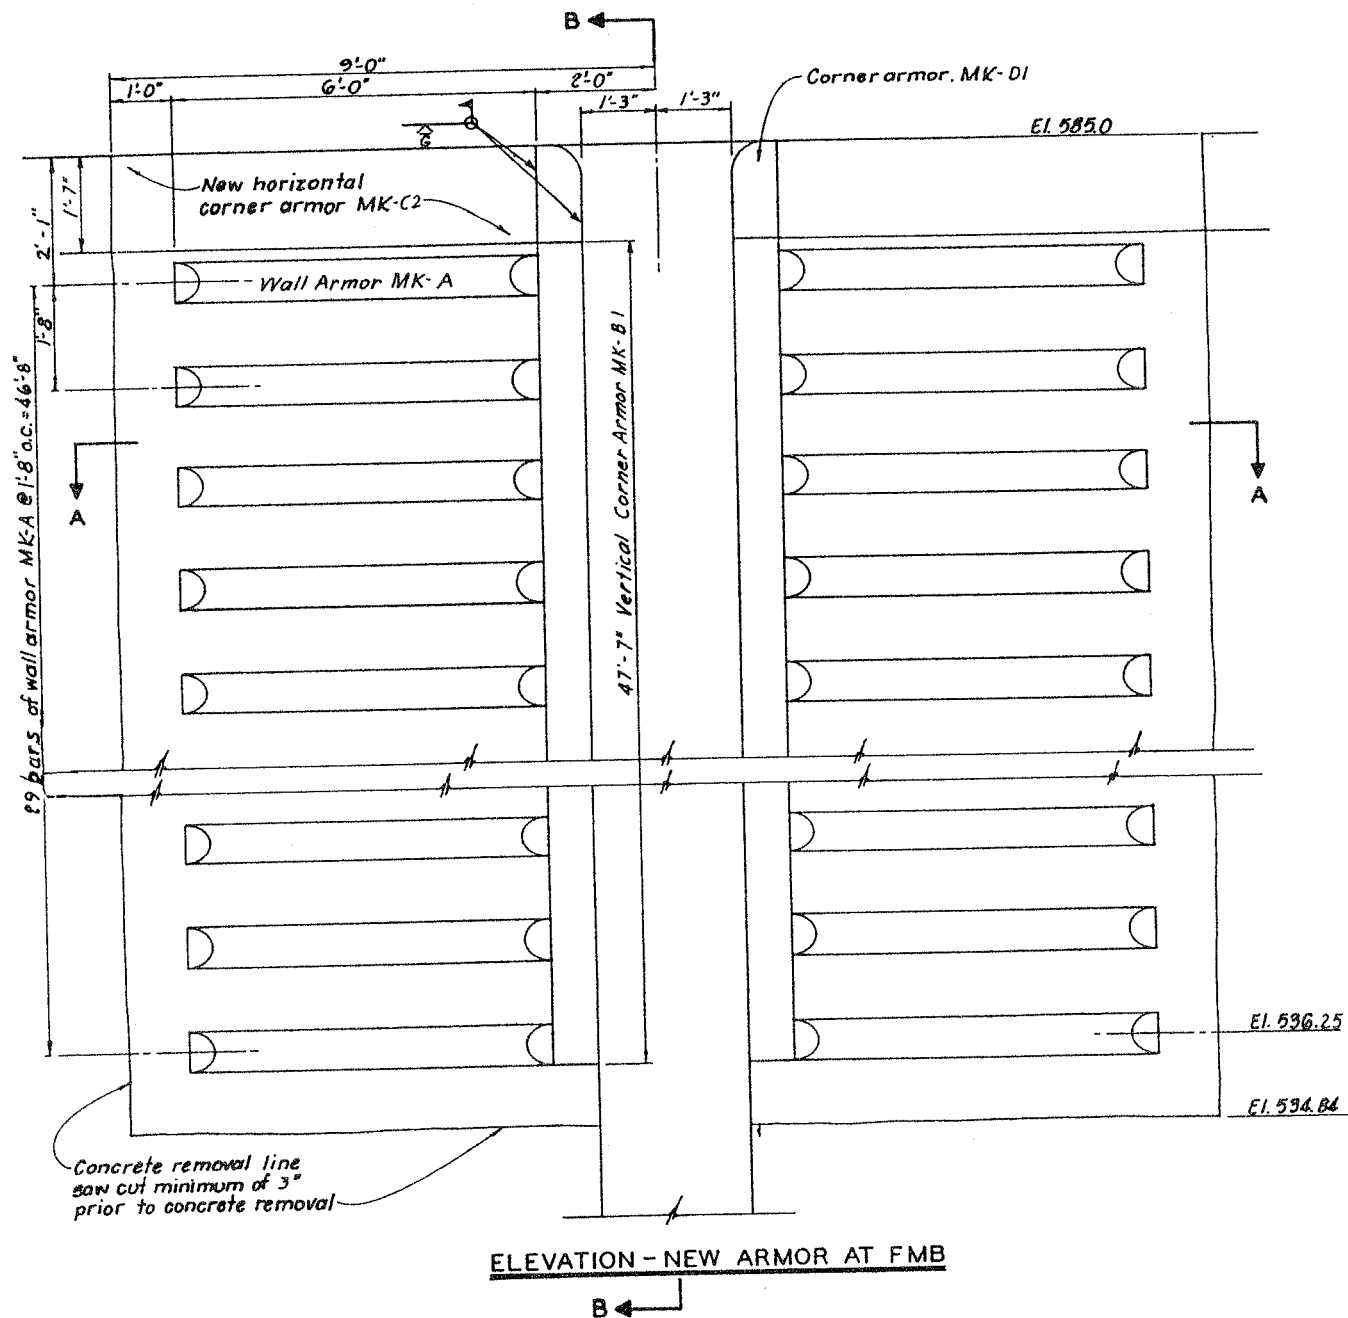
Figure 156. Floating mooring bitt details, Lockport Lock

324. Deteriorated concrete around the floating mooring bitts was removed and replaced with armored concrete as shown in Figures 156 through 160. The replacement required removal of approximately 110 cu yd of concrete. Approximately 470 dowels were used to anchor the replacement concrete. Concrete removal, installation of dowels, forming, and concrete placing were accomplished using techniques similar to that previously described for the exit ladders. The contractor's bid price for this work was approximately \$240,000.

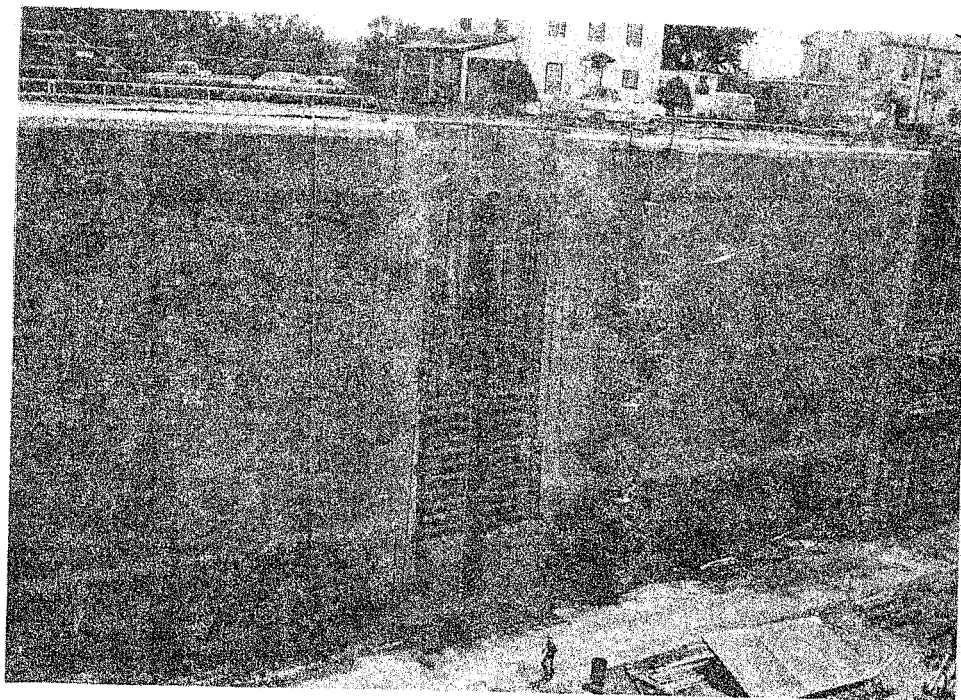
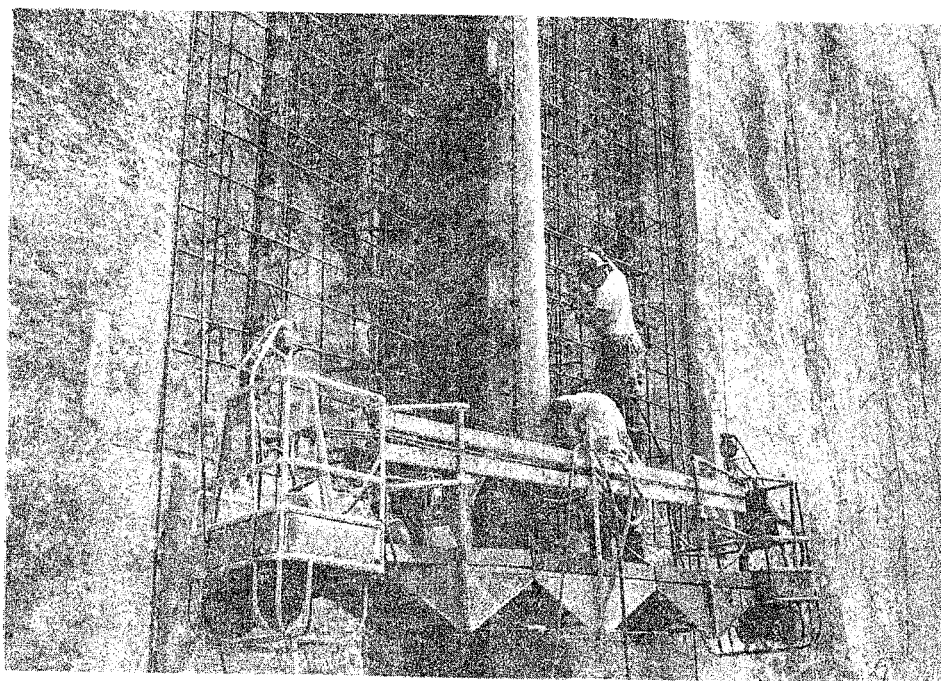
Figure 160. Replacing concrete around a floating mooring bitt,  
Lockport Lock

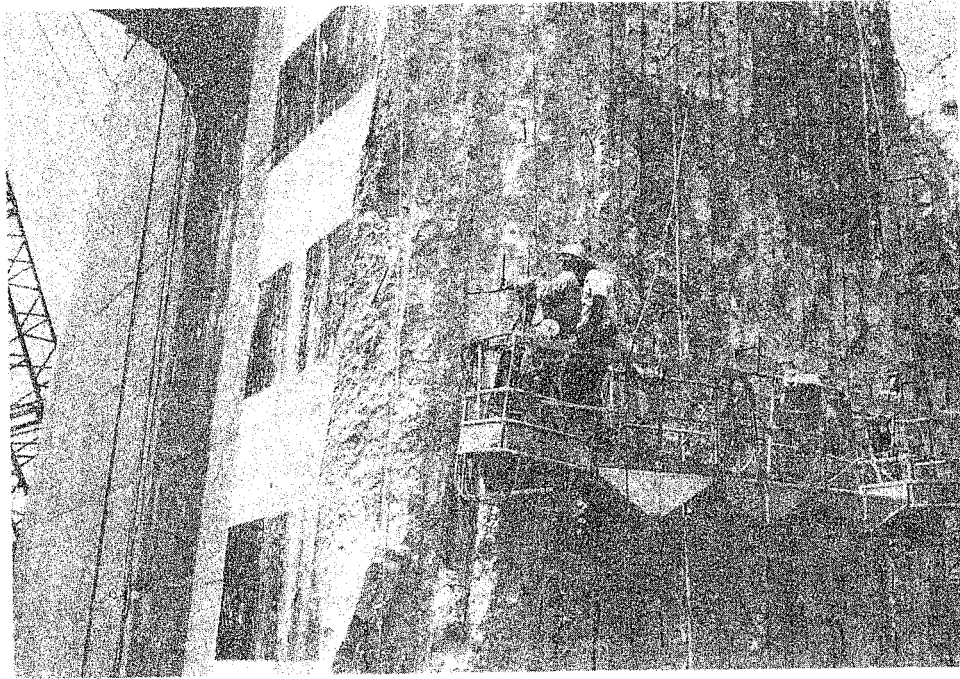
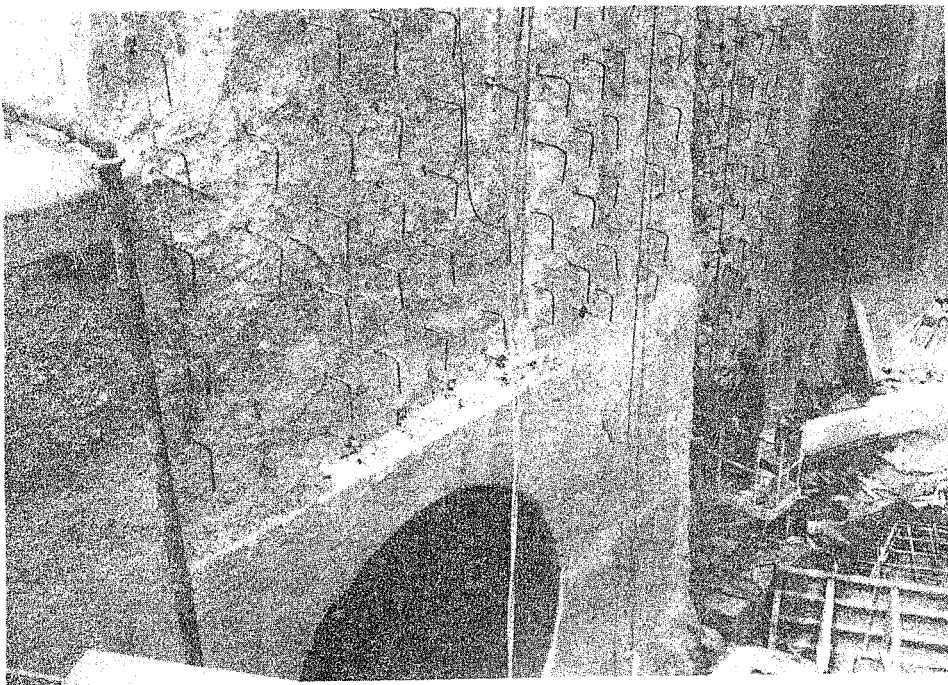
325. Since the condition survey showed that the maximum depth of concrete deterioration occurred in the lower gate bay, it was completely refaced during the Stage I rehabilitation. The refacing required removal of approximately 335 cu yd of concrete and replacement with new armored concrete. Approximately 960 dowels were required to anchor the replacement concrete (Figure 161). Bid prices for these dowels ranged from \$33 to \$74 each compared to the Government estimate of \$34. A roughly vertical crack which extended from the top of the emptying culvert for a distance of approximately 18 ft was pressure-grouted prior to placement of the new concrete.

a. Installation of dowels

b. Crack in top of culvert to be grouted

Figure 161. Rehabilitation of lower gate bay, Lockport Lock

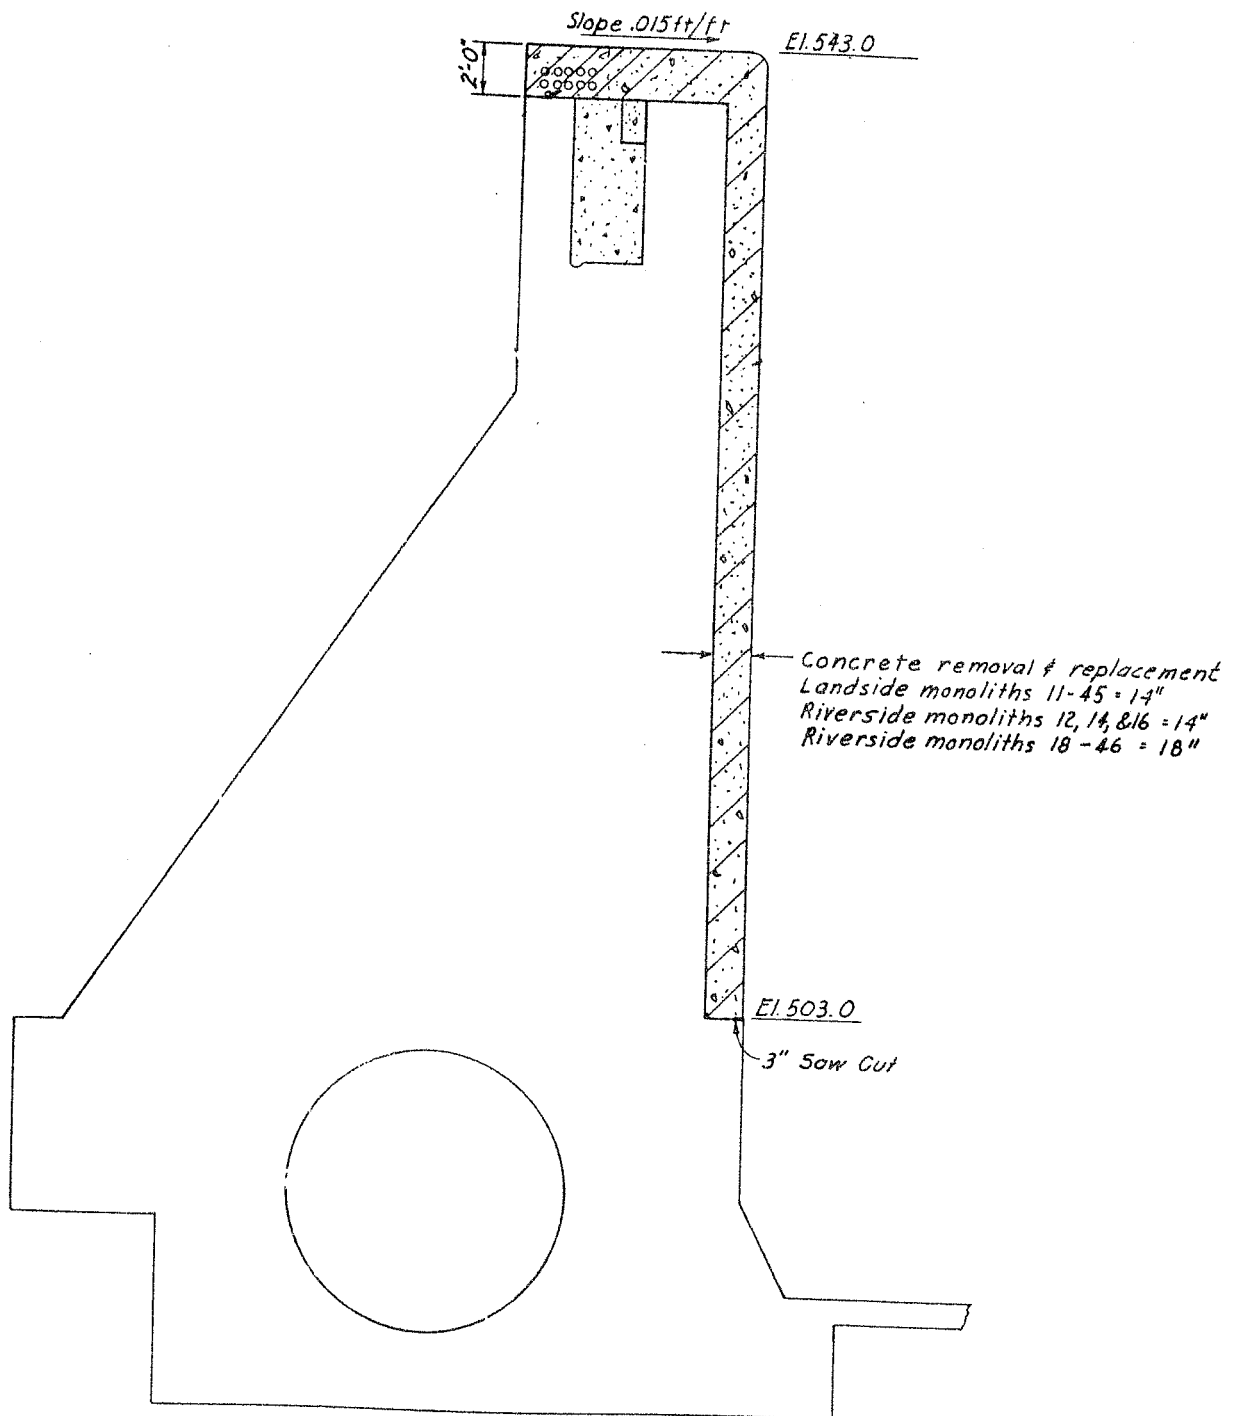
330. Resurfacing of the lock chamber monoliths involved removing approximately 2,700 cu yd of concrete and replacing it with new concrete (Figures 163 and 164). Prior to closure of the lock, the contractor started

Figure 163. Resurfacing details, chamber monoliths, Brandon Road Lock

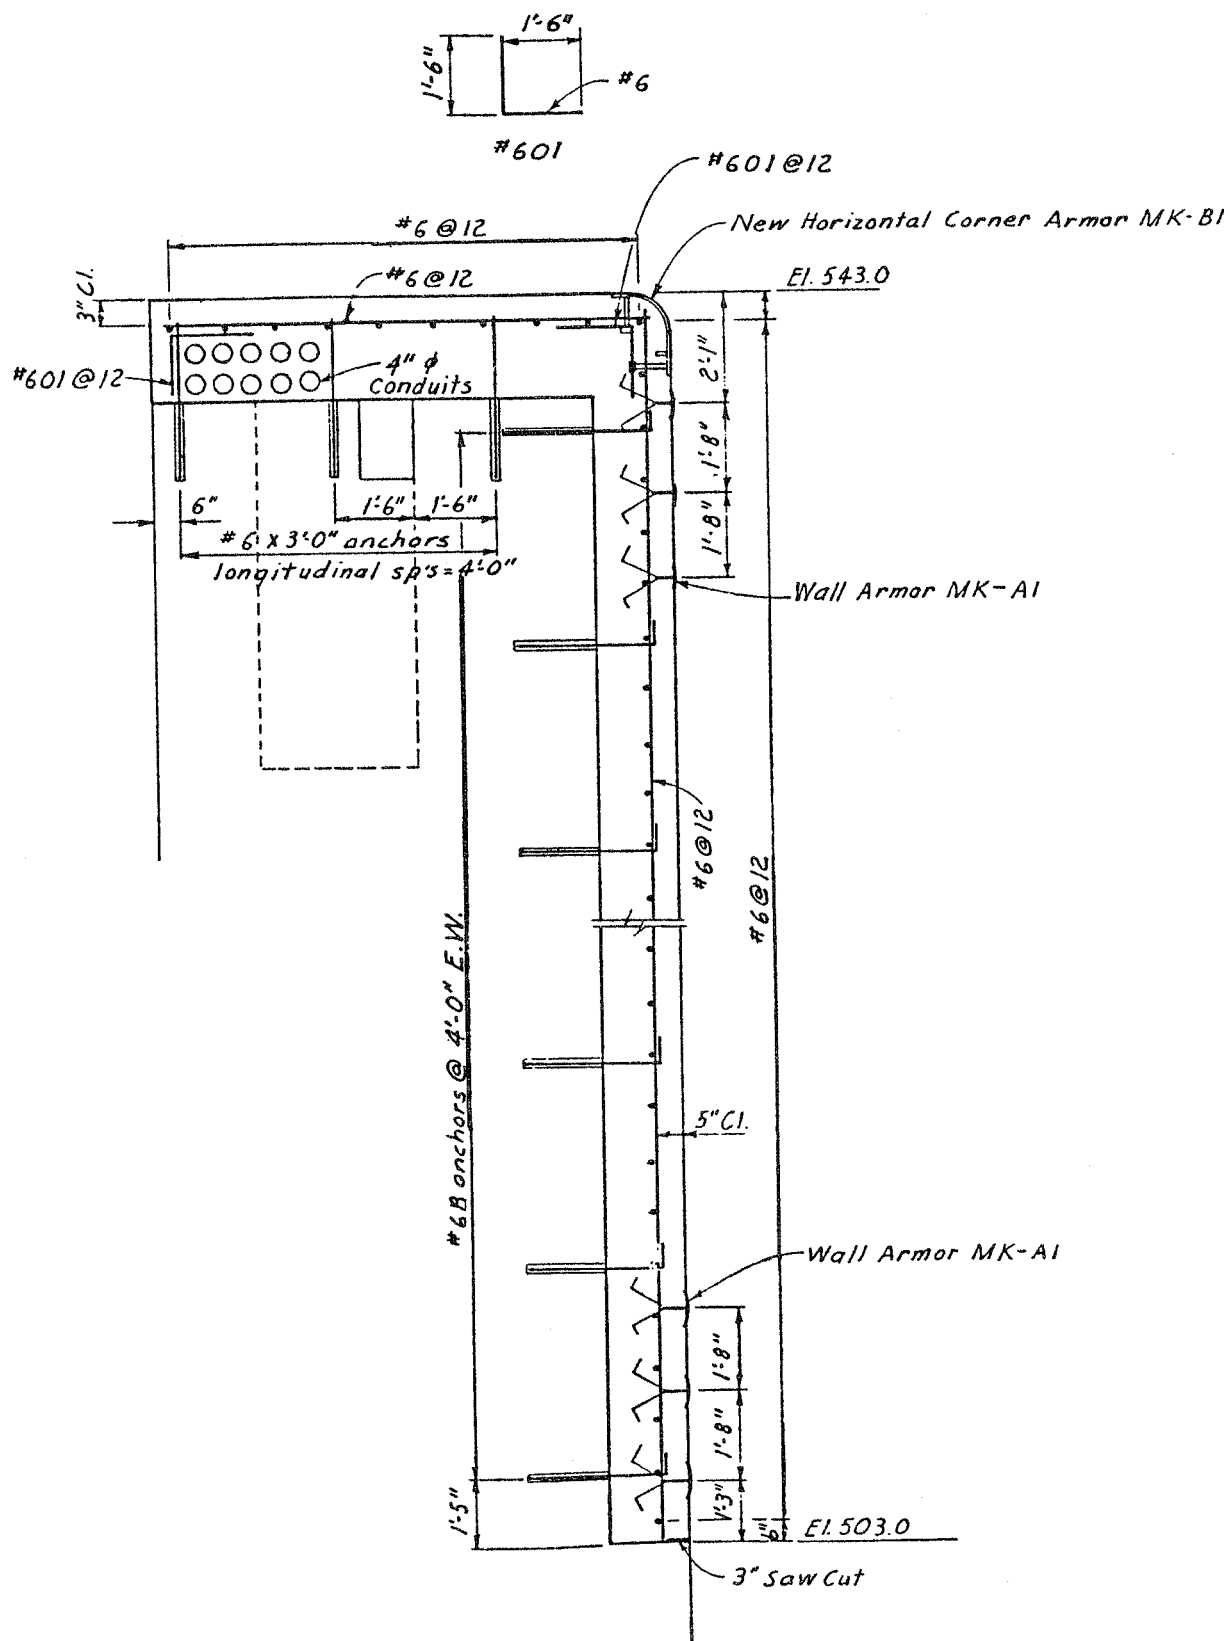
Figure 164. Reinforcing details, chamber monolith resurfacing, Brandon Road Lock

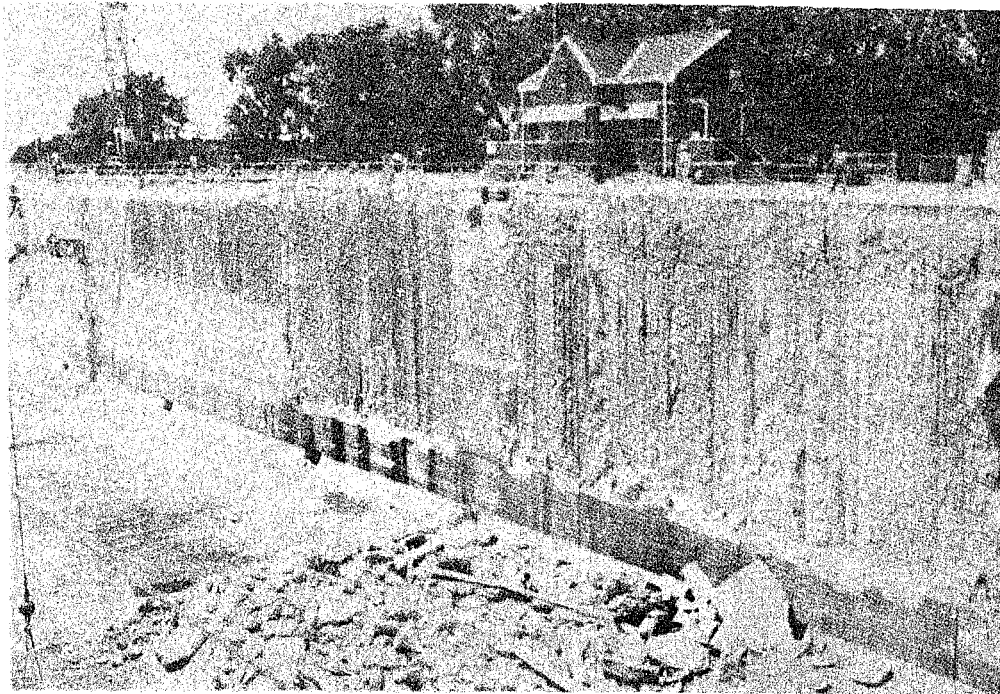
331. Following blasting, the walls were scaled to remove loose concrete still clinging to the wall surfaces (Figure 166). This scaling, normally done by manual processes such as labor crews working from scissor lifts or scaffolding with handheld hammers and chipping tools, is a very costly and time-consuming operation. The Cutter Boom, a modified piece of mining equipment having a rotary head cutter with a series of carbide-tipped teeth that grind away the concrete (Figures 167 and 168), was used to scale the walls at Brandon Road Lock. The efficiency of this equipment probably contributed to the fact that the contractor's bid price for removal of concrete in the lock chamber was \$162 per cu yd as compared to the Government estimate of \$771 per cu yd.

Figure 166. Typical concrete surface conditions following blasting, Brandon Road Lock

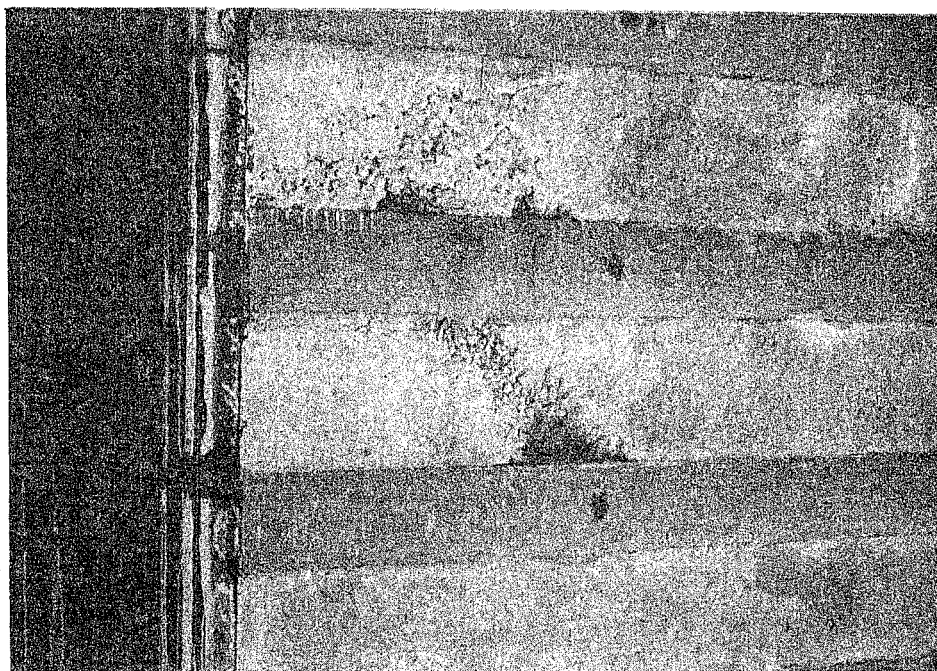
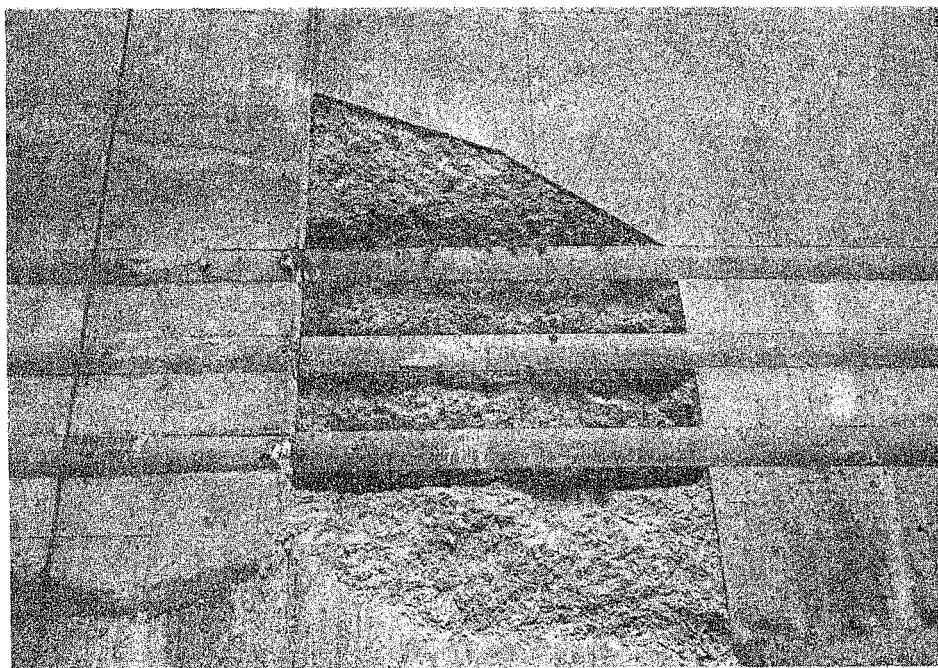
used to consolidate the fresh concrete. Because of the limited space and the depth, there was some difficulty in vibrating the concrete near the bottom of the lift in a few monoliths. The perimeter of these isolated areas was saw cut and the concrete chipped to a minimum depth of 2 in. prior to repair (Figure 178).

a. Concrete honeycomb

b. Area of concrete honeycomb prepared for repair

Figure 178. Repair of concrete honeycomb, Brandon Road Lock

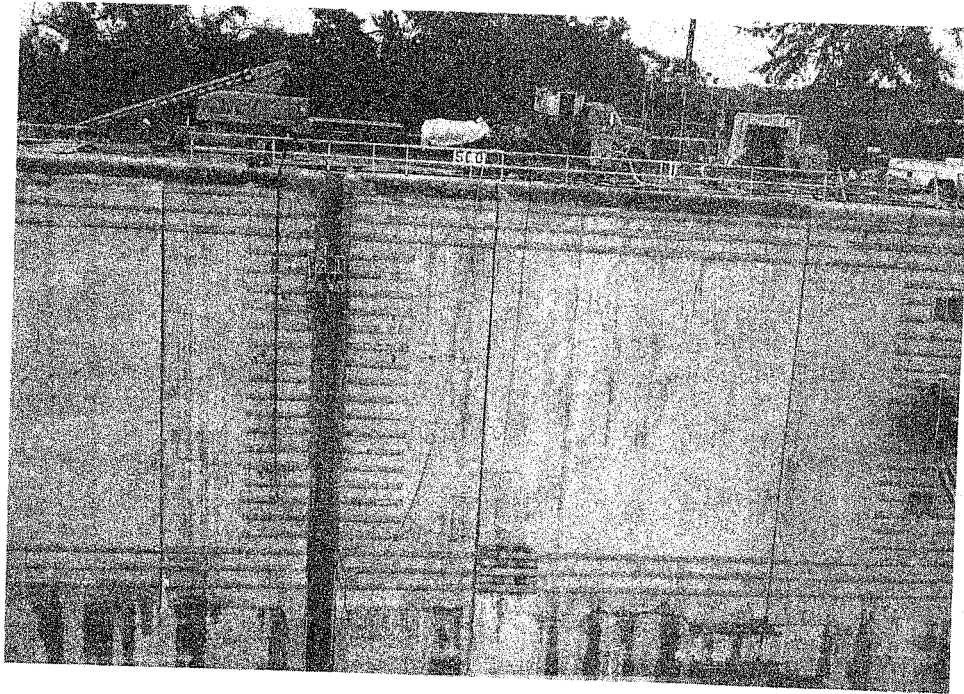
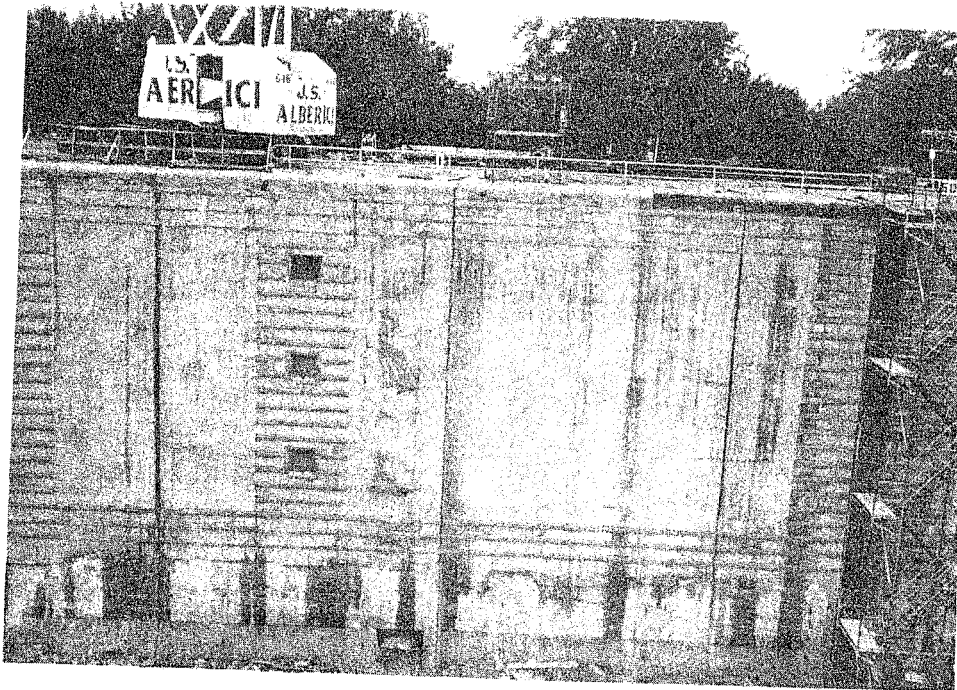
a. Landside wall

b. Riverside wall

Figure 179. Typical cracking in the replacement concrete  
August 1984, Brandon Road Lock

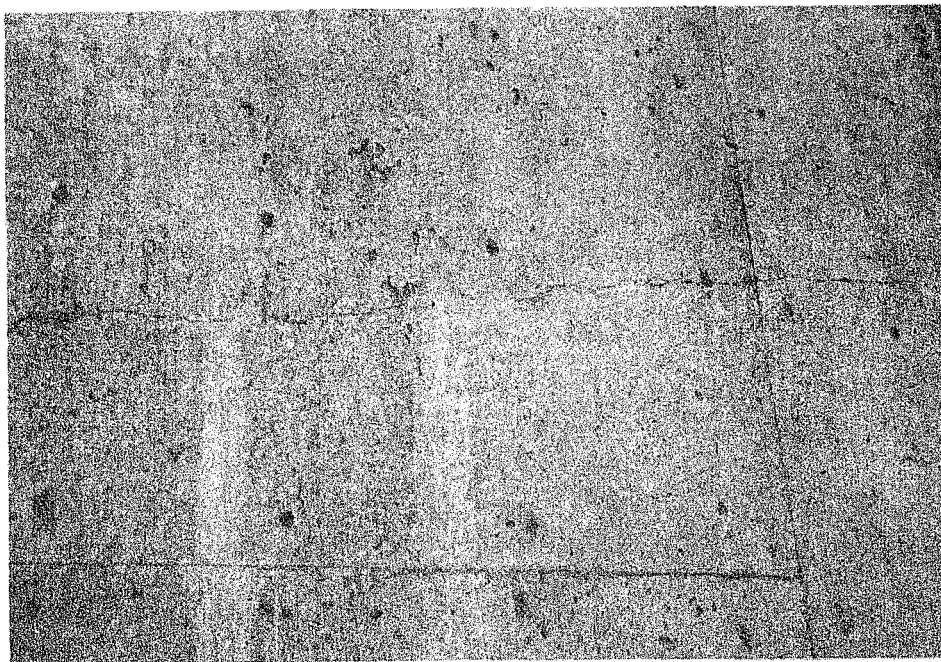
Figure 180. Typical crack in replacement concrete,  
August 1984, Brandon Road Lock

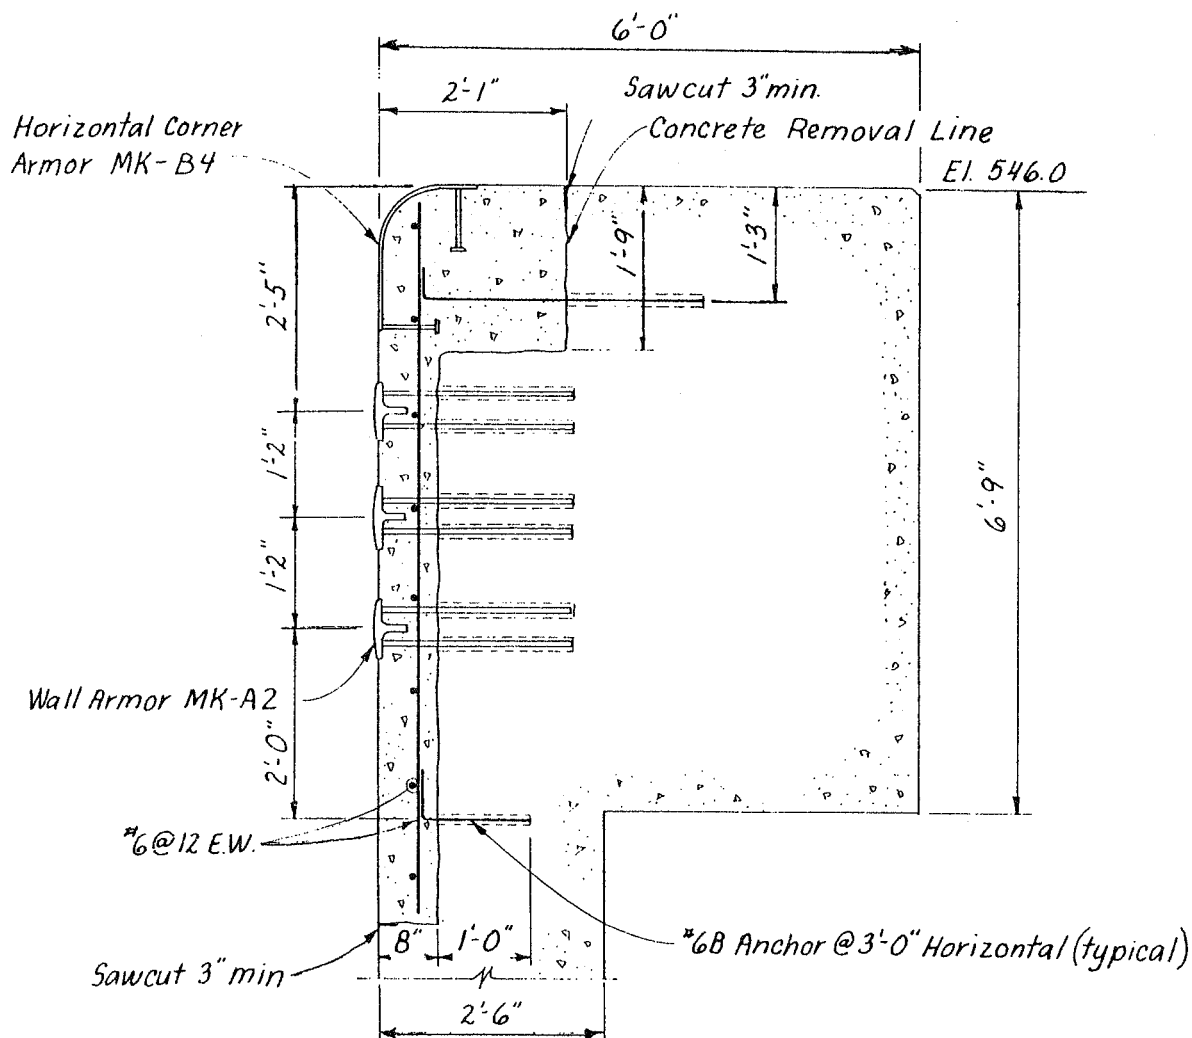
343. The top 8 ft of the river face of the upper guide wall was resurfaced with a nominal 8 in. of new concrete. This work required removal of approximately 225 cu yd of existing concrete. New wall armor and horizontal corner armor were installed as shown in Figure 185. Typical views of the

Figure 185. Upper guide wall resurfacing details,  
Brandon Road Lock

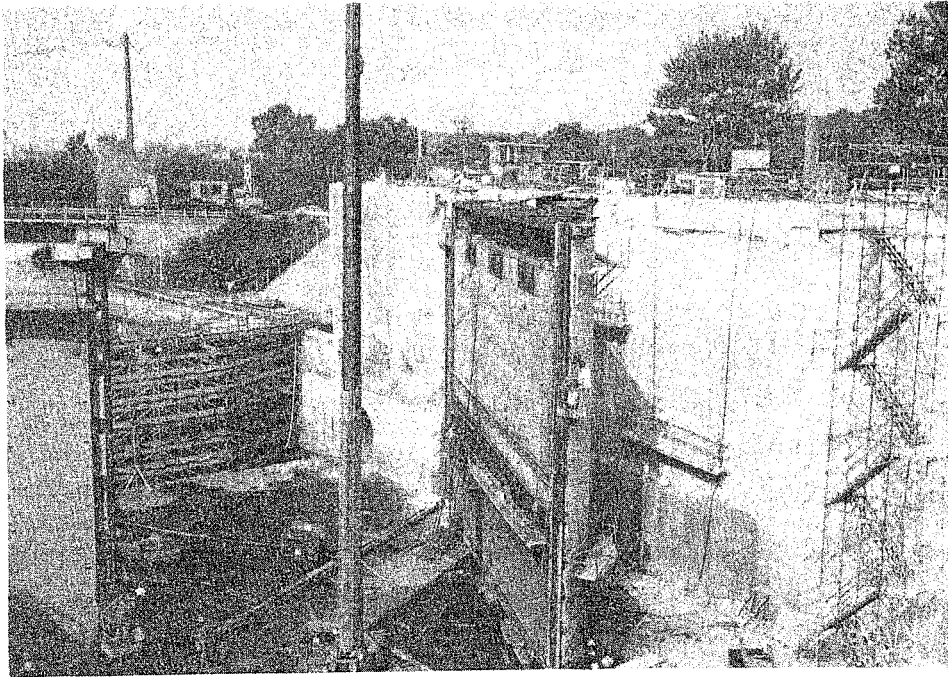
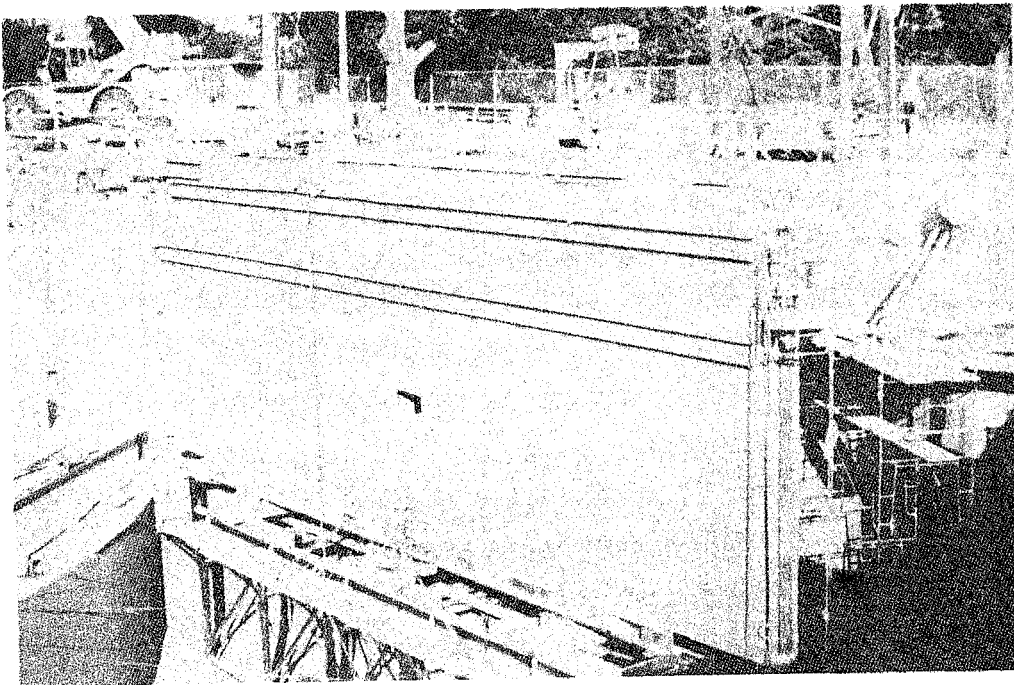
345. Rehabilitation of the upper and lower miter gates involved replacement of corroded rivets with high-strength bolts, replacement of corroded structural members, and sandblasting and painting of the entire gates (Figure 189). Many additional members that were not identified during the

a. Lower service gate being rehabilitated

b. Rehabilitated upstream miter gate ready for installation

Figure 189. Lock gate rehabilitation, Brandon Road Lock
